MONTHLY WEATHER REVIEW

A SEQUENCE OF TORNADO DAMAGE PATTERNS

Ferguson Hall and Robert D. Brewer

An investigation is made of the patterns of damage associated with a series of tornadoes in west-central Wisconsin on June 4, 1958. Three flow models are presented to account for the different patterns exhibited in different portions of the paths.

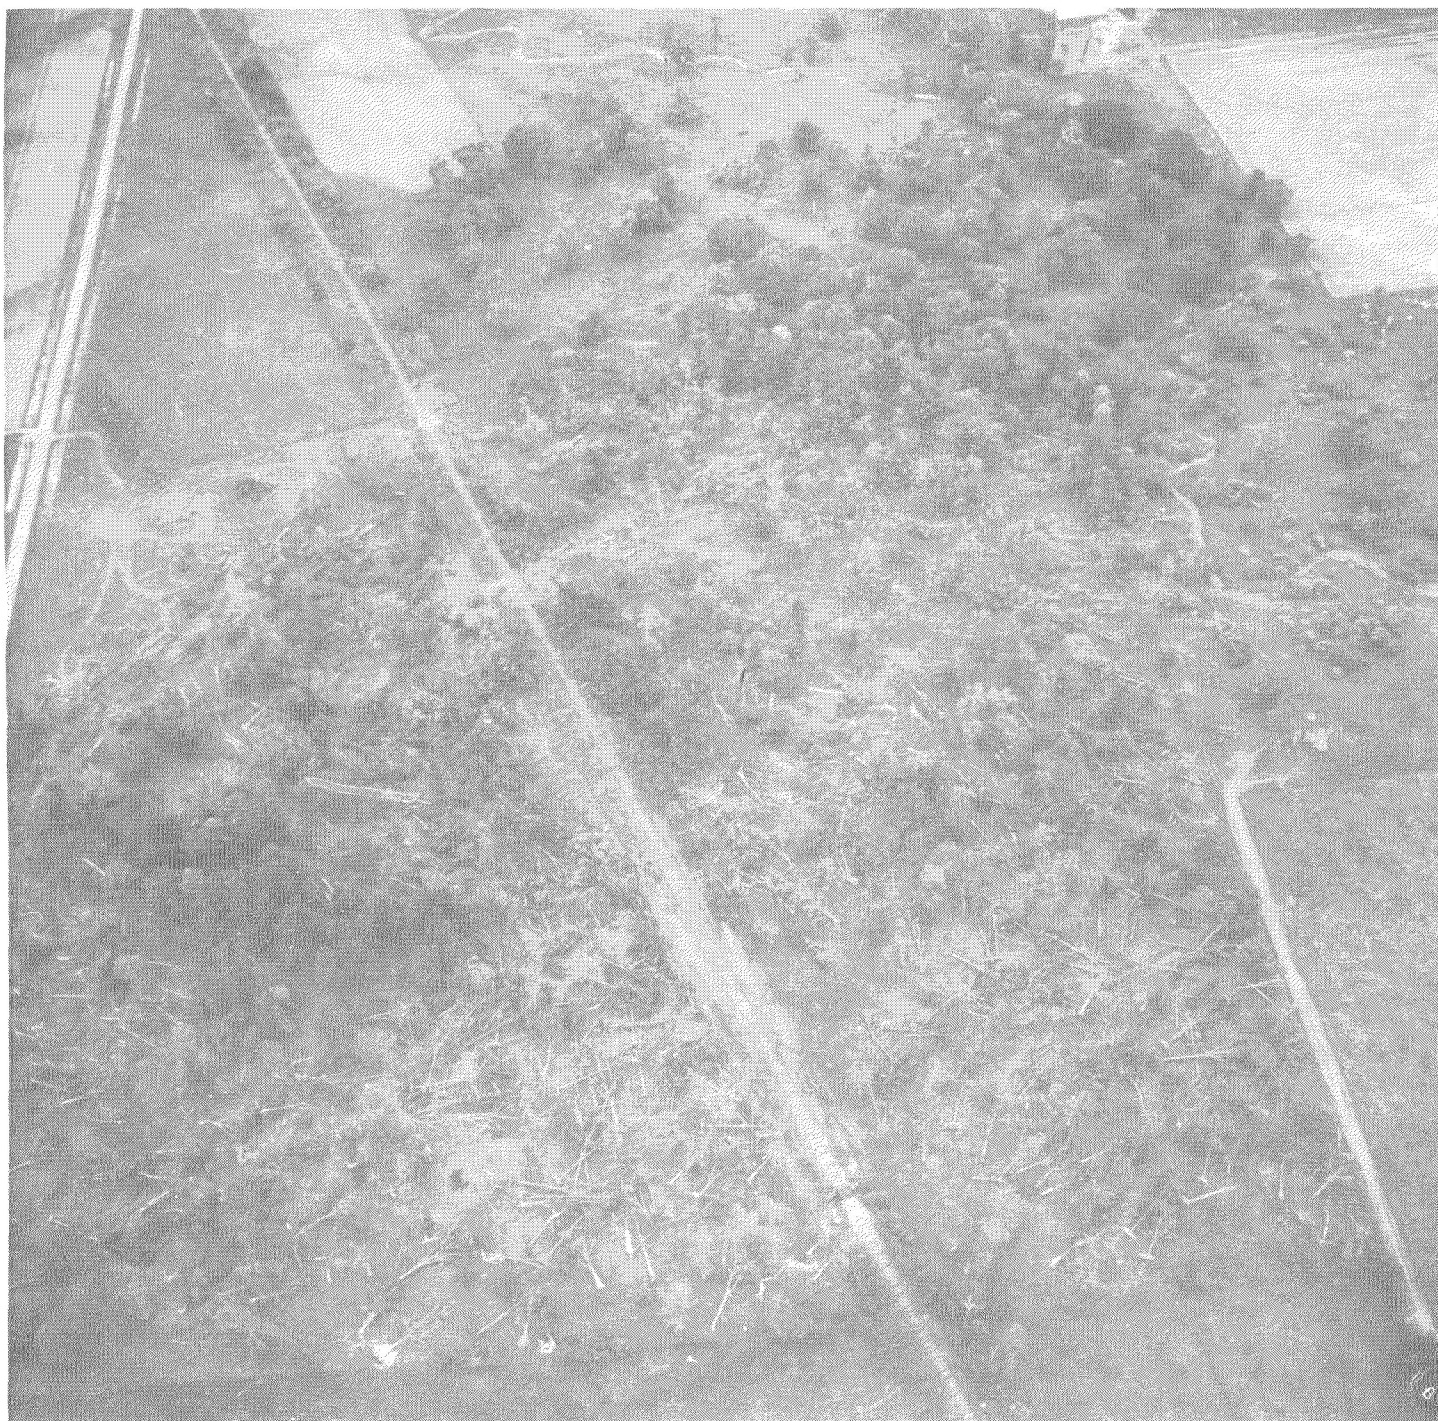
The first tornado of the series was sighted as it touched down at about 6 p.m. south of the village of Woodville. From visual reports it seems evident that at this stage the storm consisted of a distinct and typical tornado funnel. Almost immediately after reaching the ground it struck the wooded area shown in figure 2. Although the tornado's path was almost exactly centered over this wooded section, it can be seen from the photograph that damage was much more complete in the southern half (lower part of picture), where the storm's translational speed of about 50 m.p.h. was added to the rotational motion (and of course was subtracted in the northern half).² A reconstruction of this damage pattern and those immediately following is shown in figure 3, where arrows represent fallen tree directions. In many instances the trees lay crossed over one another, as indicated in the sketch, and

FIGURE 2.—Damage pattern in forested area where tornado first touched down.

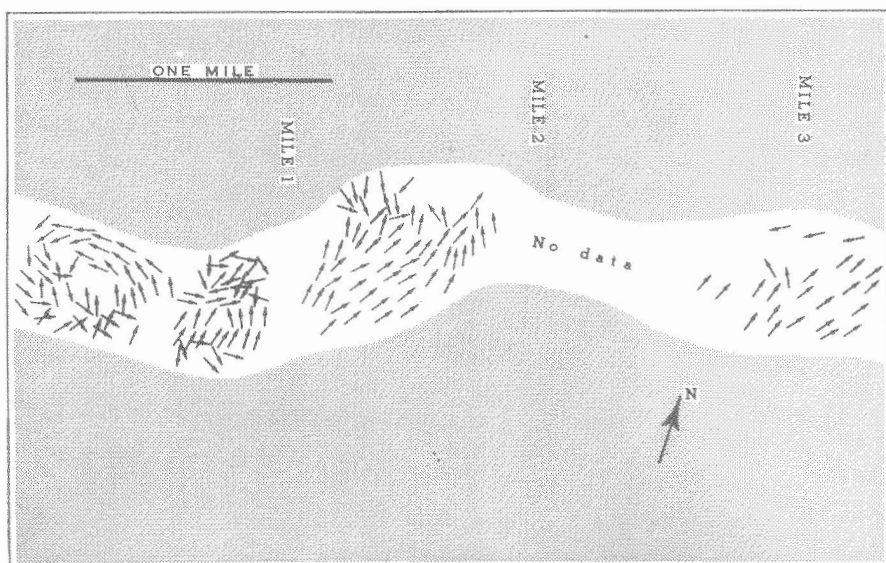
in all such cases the sequence of directions in which the trees fell corresponded to what one would expect from the passage of a compact cyclonically rotating vortex. As can also be seen, the "reverse" flow along the northern side of the path became much less prominent as the storm progressed, suggesting that rotation had slowed somewhat so that the translational speed was more effective in countering the backward-moving component, or that the translation was much faster. This feature was an early indication of the highly variable character of the storm patterns which was typical of the entire track.

FIGURE 3. (At left)—Reconstructed damage pattern over first segment of tornado path. Arrows represent fallen trees.

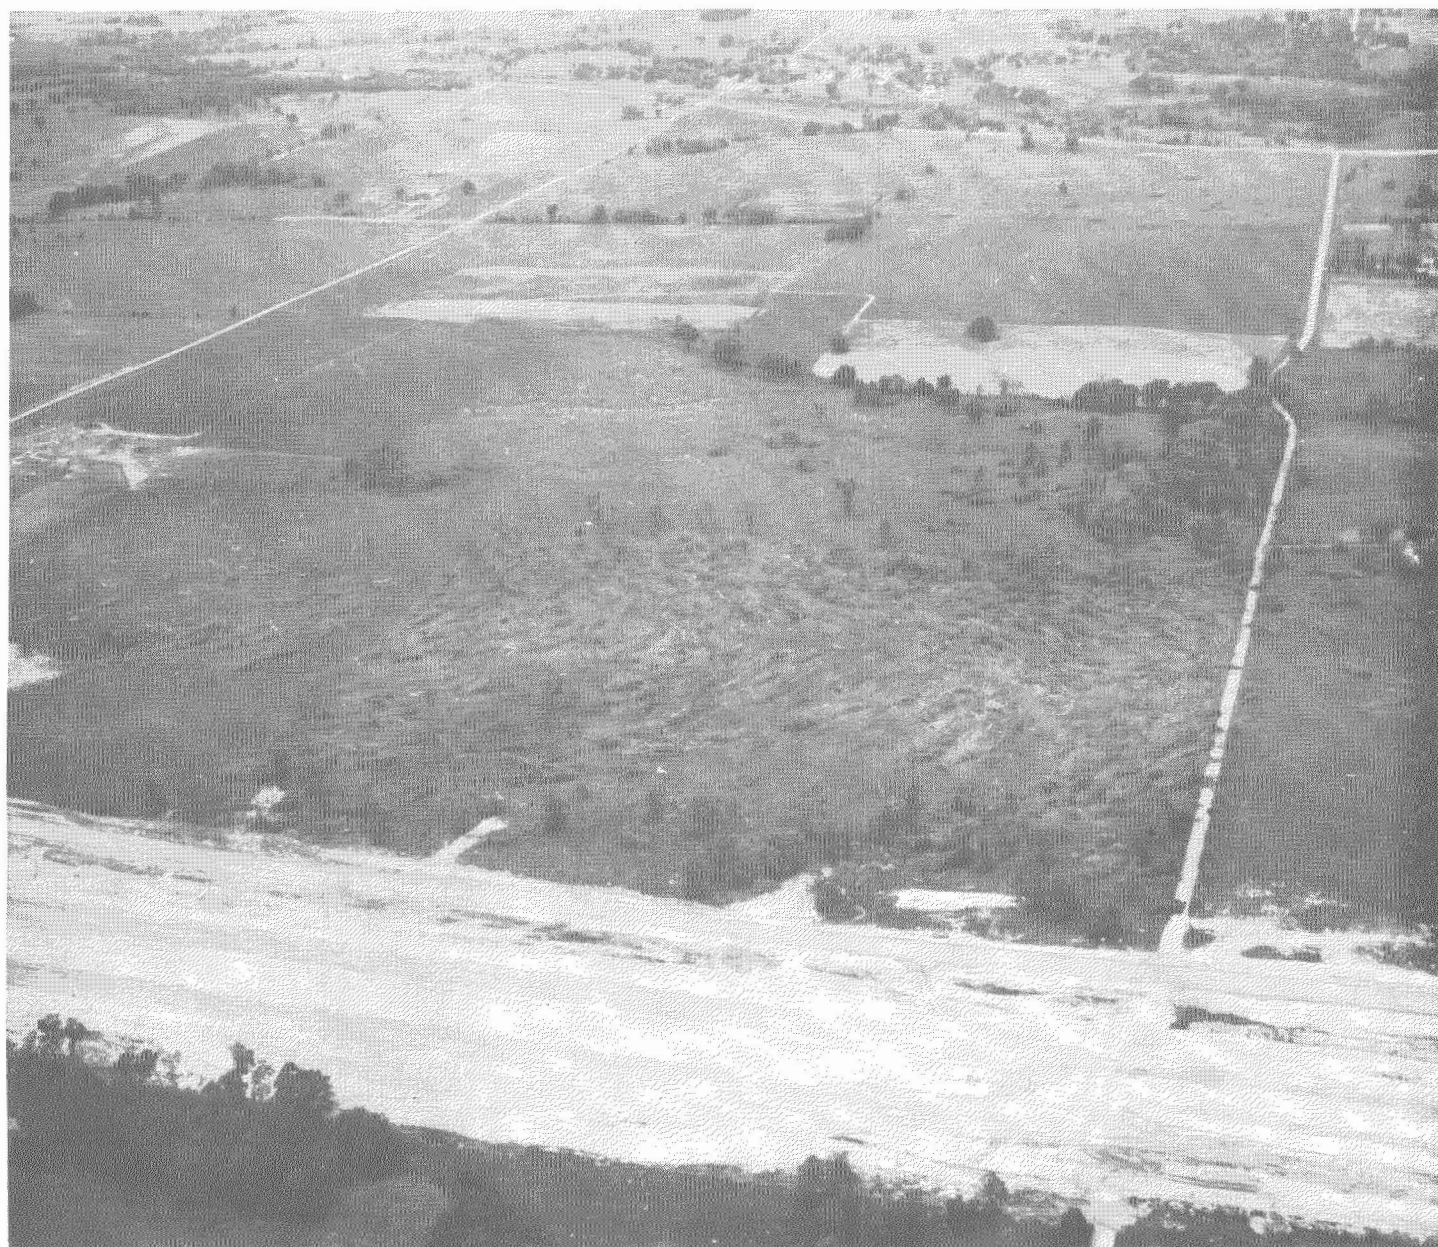
Pronounced damage patterns were infrequent for the next 8 miles of the path, and the storm may have been on the ground only intermittently or may have missed most of the heavily wooded areas. However, at about mile 7 another wooded tract was struck, apparently head-on, and again the pattern, as can be seen in figure 4, leaves unmistakable evidence of a well-formed and classical tornado funnel.

FIGURE 4. (Below)—Damage pattern showing distinct circularity.

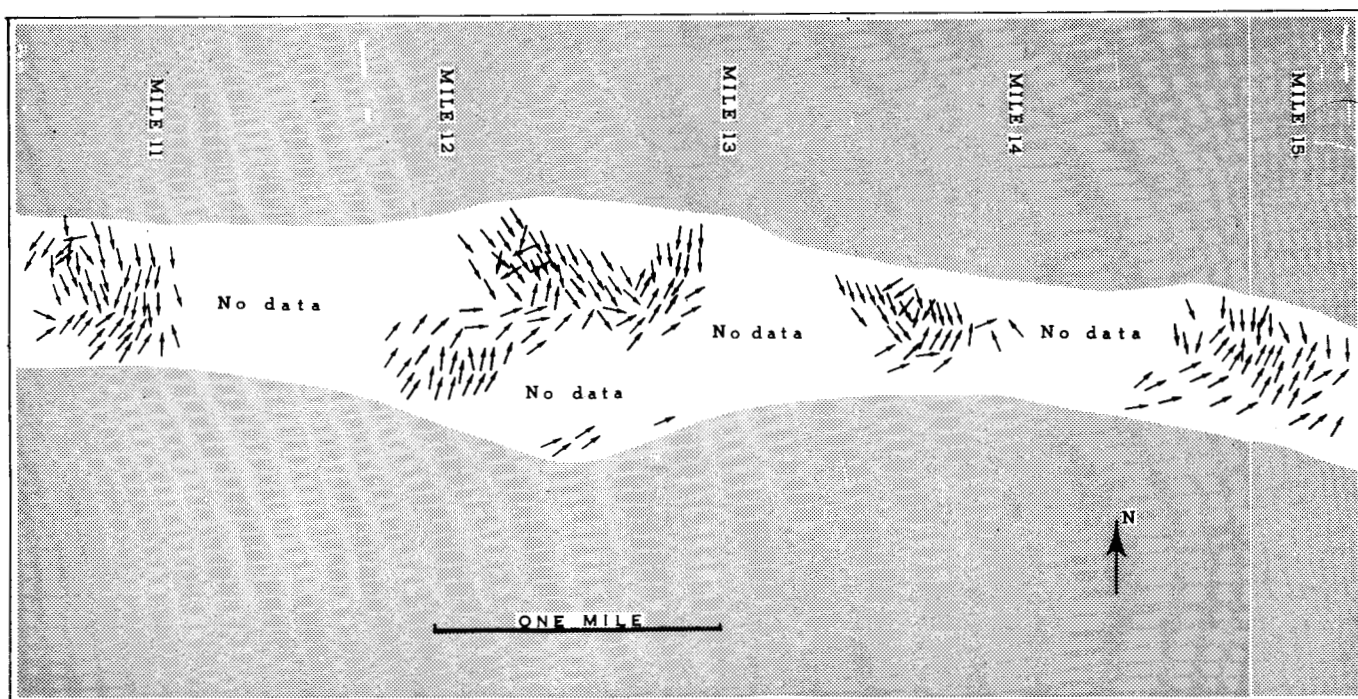
"herringbone" pattern, with the fallen trees directed forward and inward toward a sharp line of separation (at this line the trees sometimes even crossed each other on falling). The reconstructed damage patterns along this portion of the path are given in figure 5. Such patterns suggest the passage of a fast-moving center of strong inflow or convergence, with only a faint suggestion, on the northern side of the path, of the "reverse" flow associated with a funnel.

FIGURE 5.—Reconstructed damage pattern of the "herringbone" type.

Model (*b*), representing strong inflow toward a moving center (implying a major sustained updraft into the storm center), seems consistent with the herringbone damage patterns of figure 5, where the survey found no significant evidence of rotation. If this interpretation is correct, the funnel must have been lifted off the ground accompanying a resurgence in cloud formation taking place at or near the storm center. An unbalance between pressure gradient and winds, perhaps caused by friction, may have resulted in strong upward motion around the funnel, pulling it upward—possibly the same mechanism responsible for the formation of the “collar” or “ruffle”

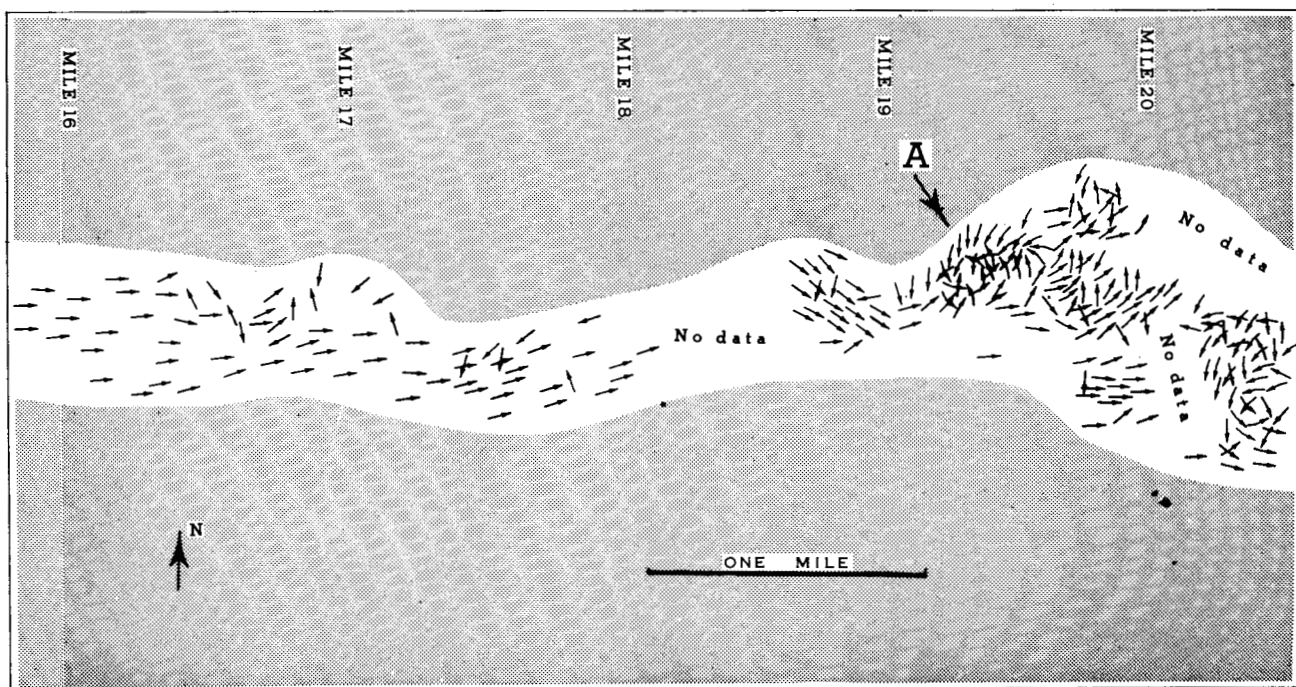
Continuing along the path, the pattern of the next few miles (roughly miles 17 to 19, fig. 6) returned to the general appearance of that seen in the later part of figure 3, where a strong forward flow along the southern edge of the path accompanied a rather weak and confused reverse flow along the northern edge of damage, all suggestive of modest rotational speeds coupled with pronounced forward movement. But beginning at mile 19 and continuing through mile 21 the full rotary pattern again became well marked, presumably due to an increase in vortex speed or to a slowing down in forward motion, or to both. The reconstructed damage pattern for this segment is given in figure 6. Not only did the pronounced rotation reappear, but the path showed an abrupt change

in direction. As one explanation, the funnel may have continued toward the northeast, but then turned sharply southward and thence back on an eastward course. Alternatively, the original funnel may have dissolved as it moved northeastward, to be replaced by another forming to the south, as was the case on a much larger scale with the individual storms of the system, as mentioned earlier. Figure 7 is a photograph of the destruction which oc-

FIGURE 6.—Reconstructed pattern near midpoint of path.

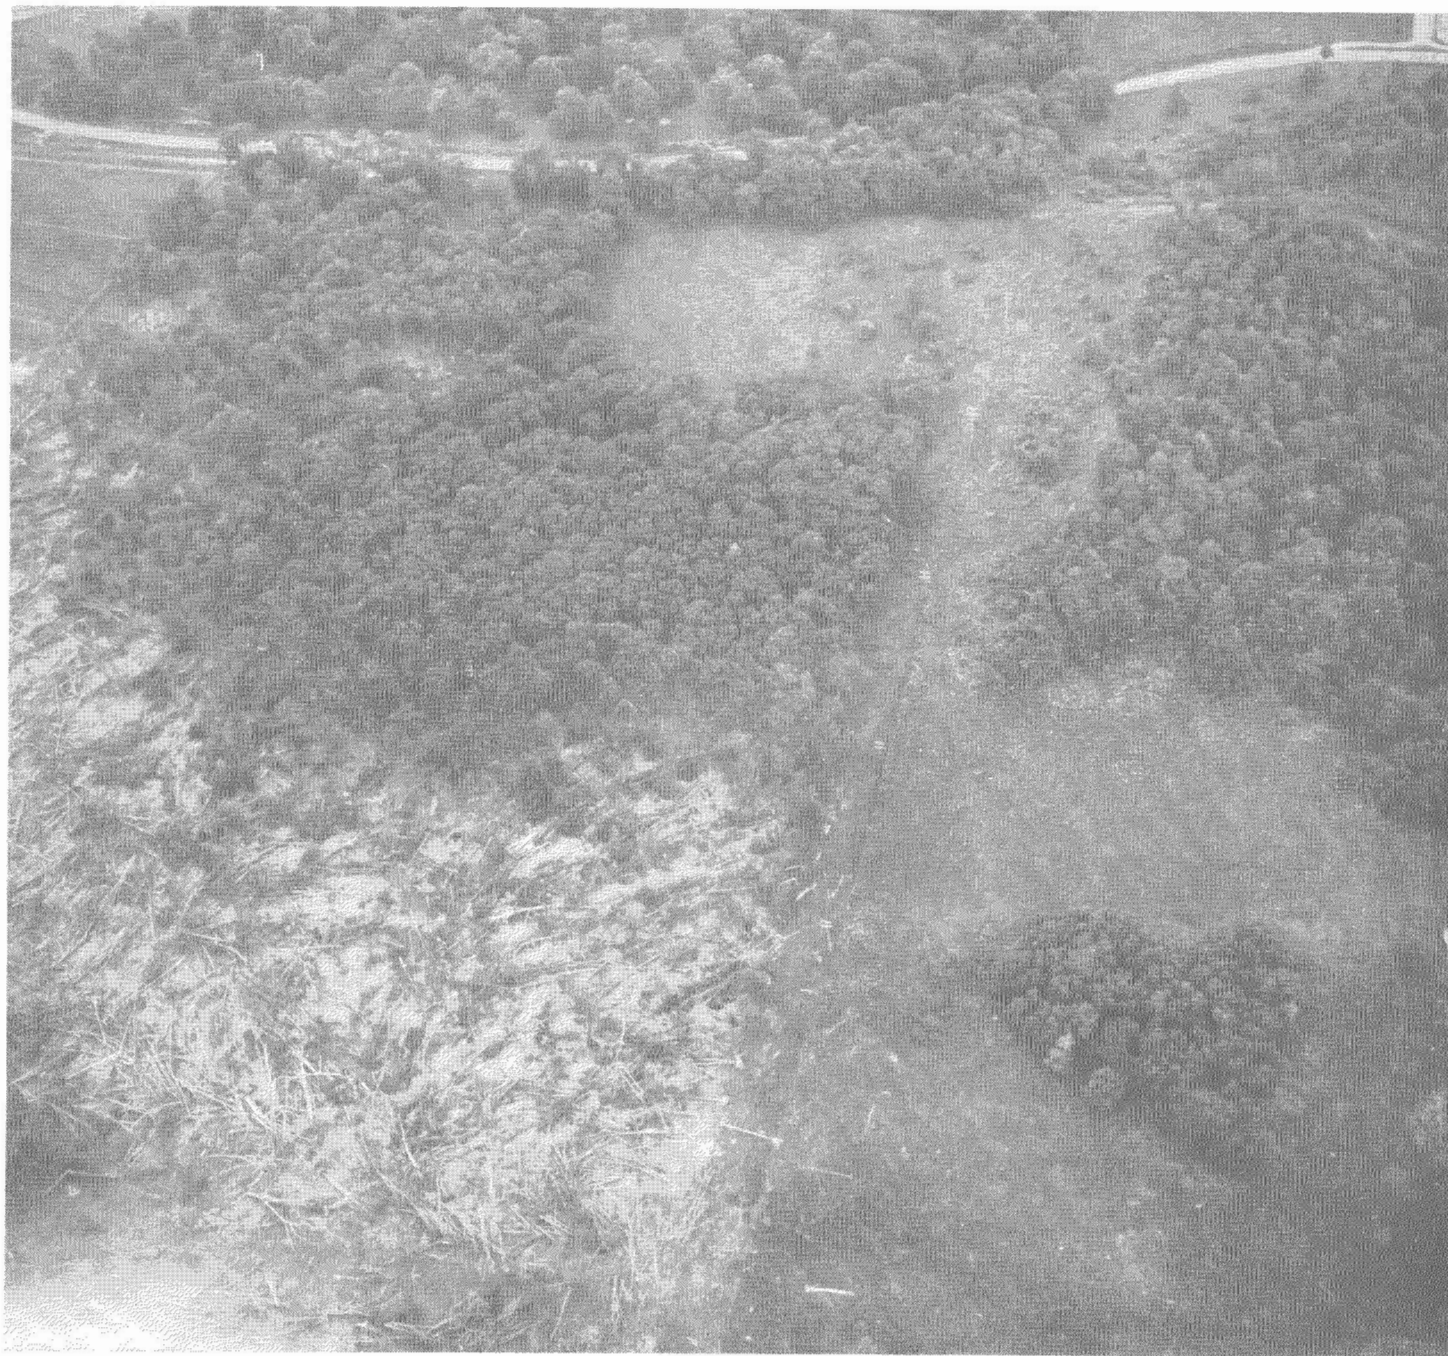
curred at point "A" of figure 6, and illustrates the circularity of the pattern. Also significant here is the sharp demarcation between destroyed and undamaged forest.

FIGURE 7.—Circular pattern at point "A" of figure 6. Note sharp demarcation between damaged and undamaged trees.

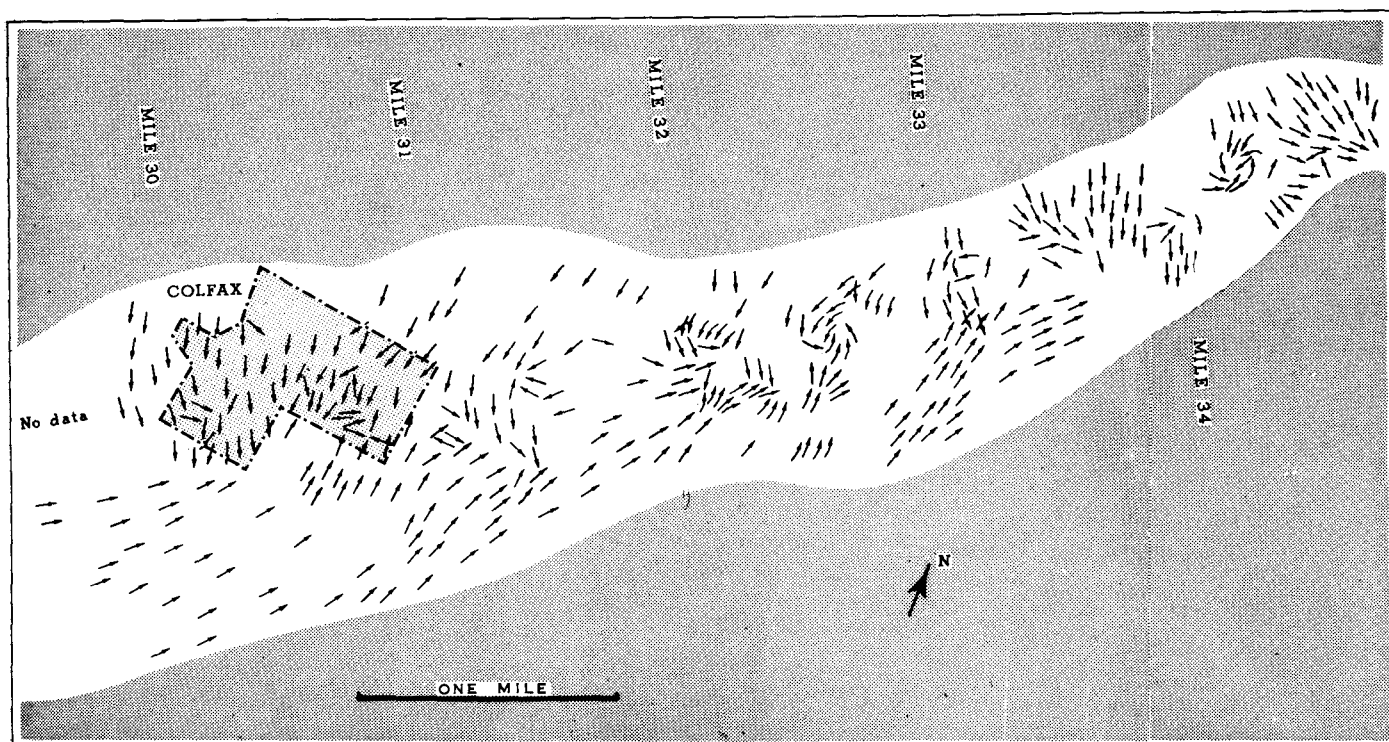
tion of the village of Colfax, the southeastern one-third of which suffered almost complete destruction, with widespread but more irregular damage elsewhere. Perhaps the most impressive feature of the patterns is the sharp line of demarcation between the opposing flows from the north and from the southwest. From place to place along this line can also be noticed the confused and at times circular patterns characteristic of high-speed vortex motion. Substantial alterations in pattern as the storm progressed are quite noticeable and might indicate highly

FIGURE 8.—Reconstructed pattern of final portion of path. Built-up portion of village of Colfax shaded.

unsteady storm structure, except that here the terrain is quite rolling or even hilly, and may have been sufficient to distort the flow. Taken as a whole, however, the patterns suggest a central high-speed funnel or vortex surrounded by an intense cyclonic circulation giving destructive winds out to a radius of $\frac{3}{4}$ mile. The highly convergent appearance of the damage also suggests, however, the presence of intense inflow toward the center of the storm sufficient to distort the pattern normally produced by a moving rotary system of winds. Figure 9 shows a view of Colfax, looking northward from the southern village limits.

The final stage of the storm's course, as illustrated in figure 8, seems to differ substantially from the earlier patterns, and is most closely approximated by the three-way combination of rotation, translation, and inflow of model (*c*). This model appears to explain the flow from the southwest along the bottom of the path separated quite sharply from the flow from the north along the upper portion. A number of observers in this portion of the storm path reported marked wind shifts as the storm approached closely. At first, winds were from an easterly direction, with enough force to blow over smaller trees. A few seconds later the main storm struck with winds from a southwesterly direction, and with much greater force. Such a sequence would not be compatible with

in figure 8. For this reason no one hypothetical model can be expected to provide an exact "fit" to the observed patterns. Also, as has been mentioned, the rolling and hilly topography in this section may have had a decided influence on resulting damage by producing distortion of the wind flow.

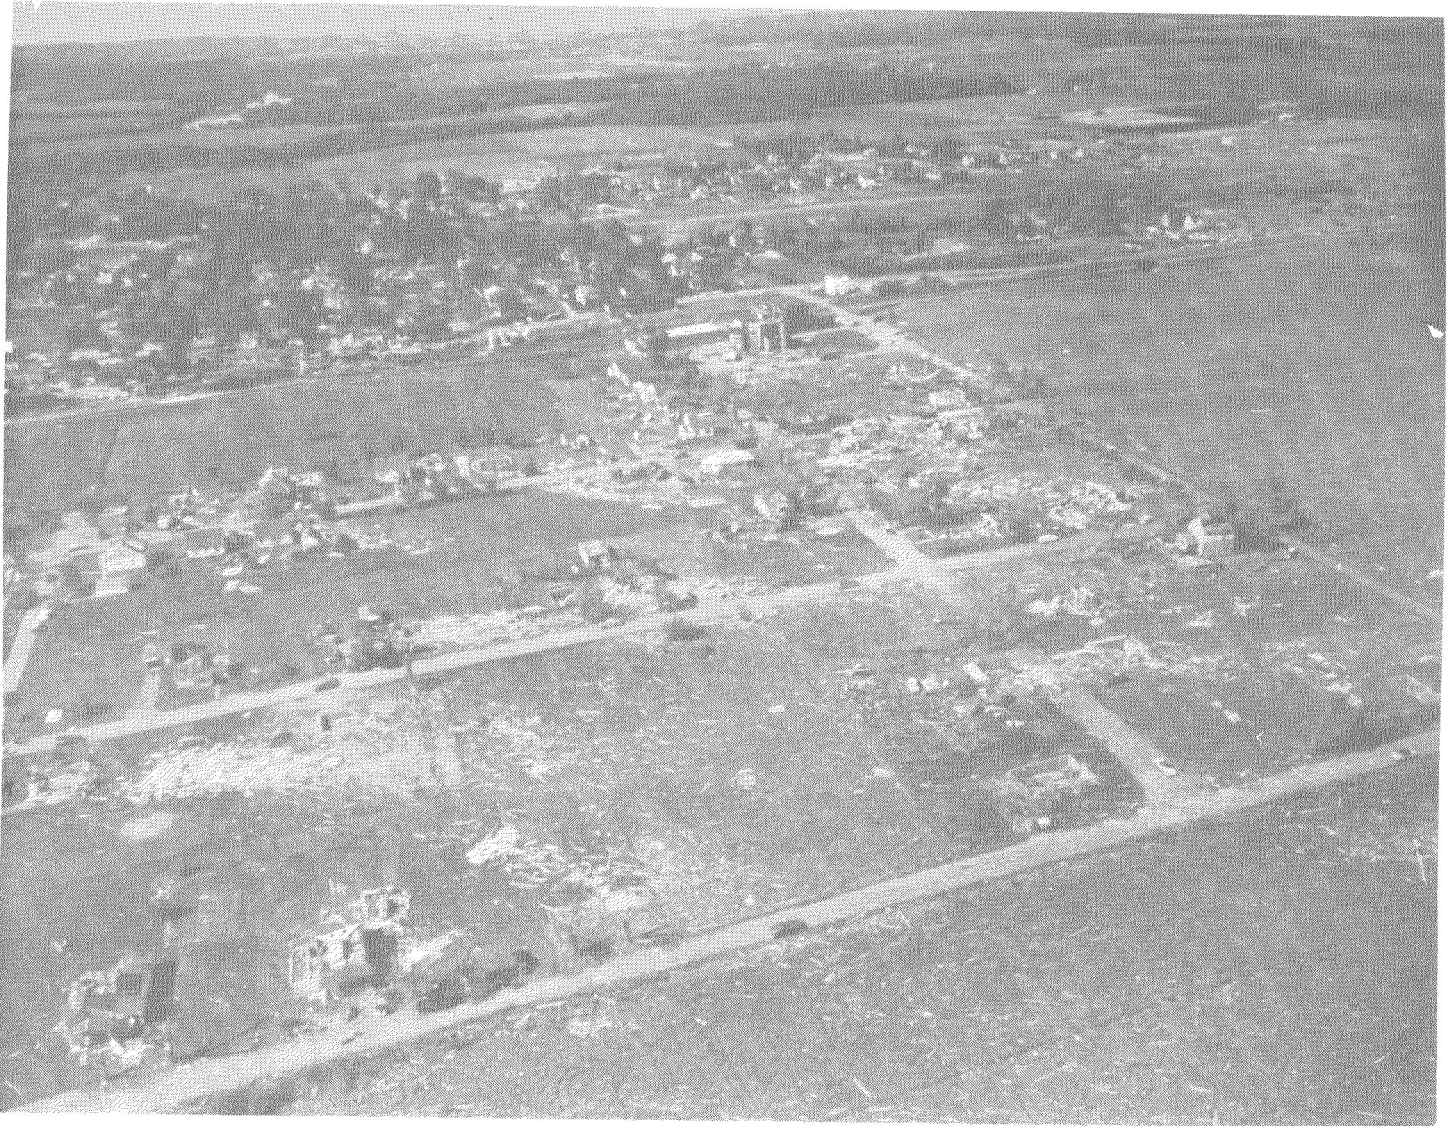
FIGURE 9.—View from south of part of damage at Colfax, Wis.

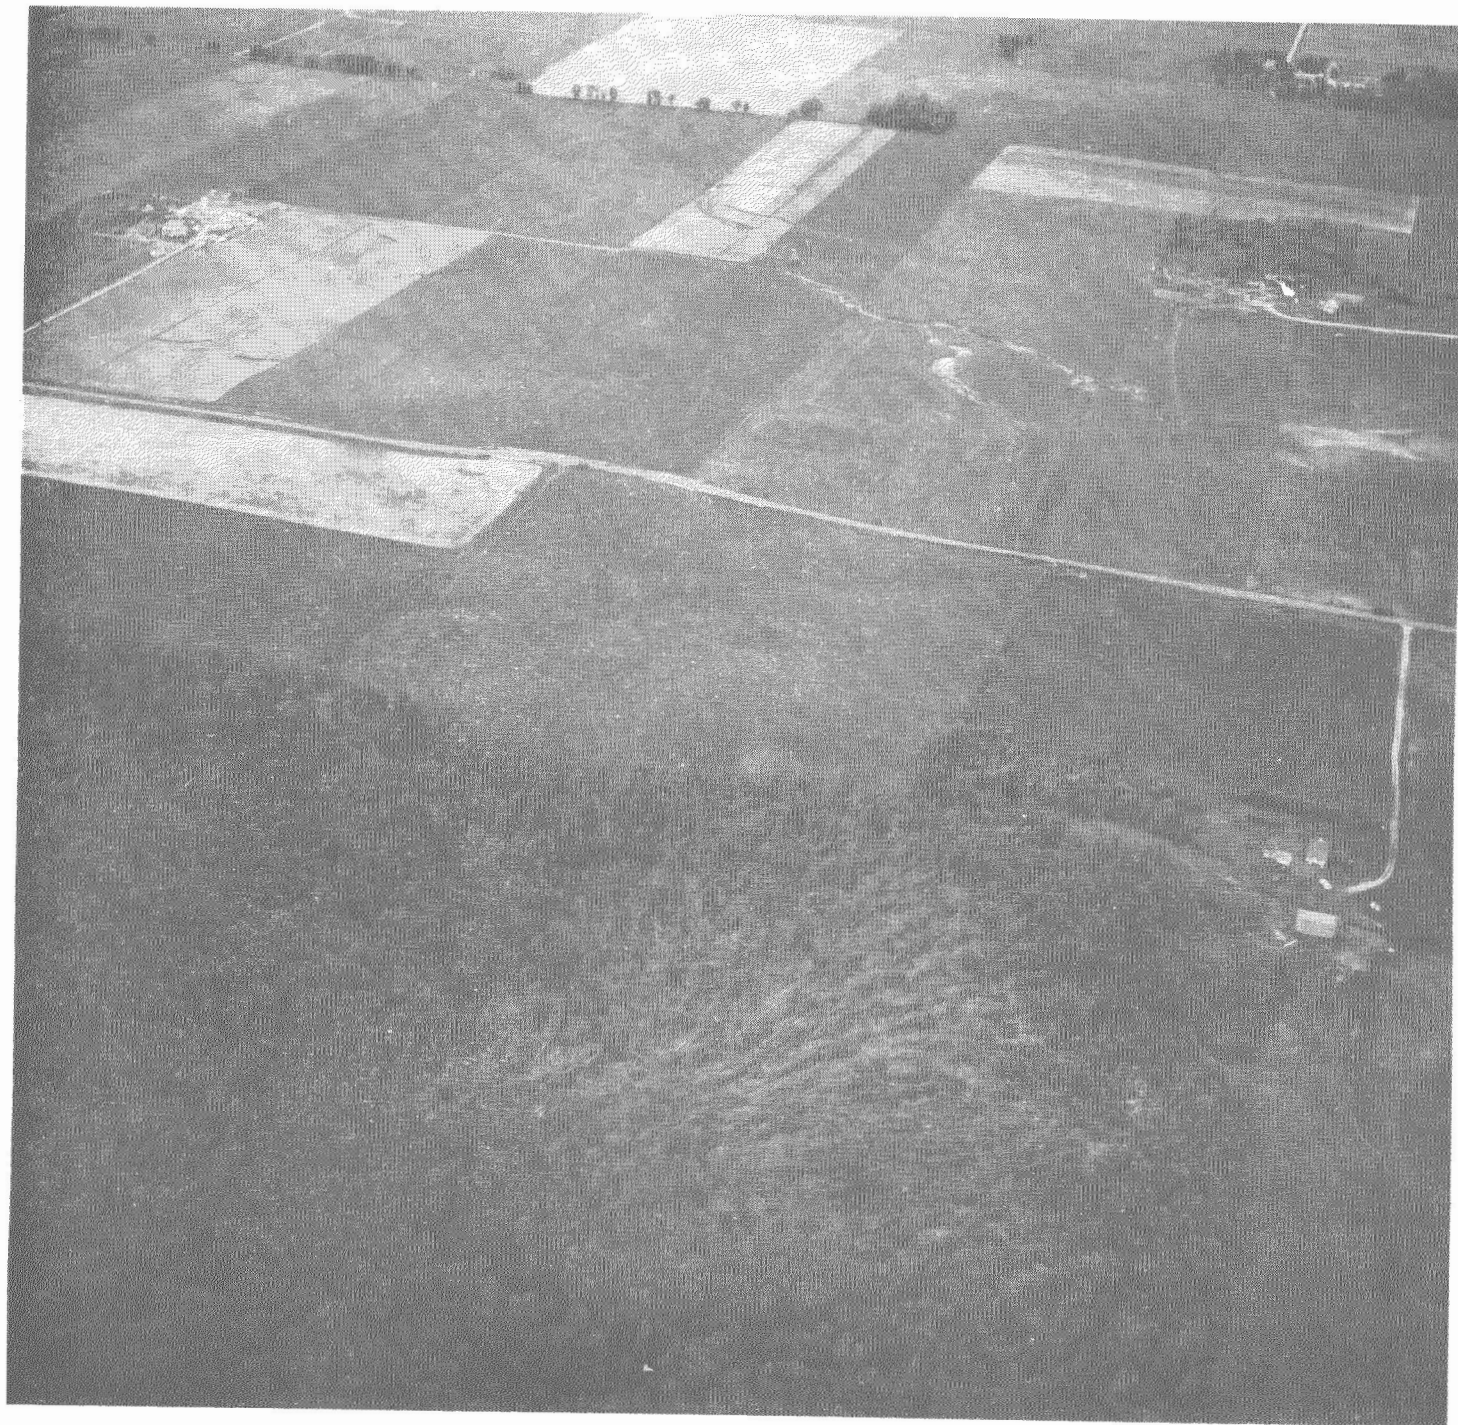
A flow pattern of quite different character is illustrated in figure 11, which shows a distinct fan-shaped or "crow's-foot" distribution of felled trees. This pattern occurred at mile 26, and a similar one occurred a mile earlier. Over

FIGURE 11.—Fan-shaped damage pattern.

level terrain one would undoubtedly conclude that such a pattern was produced by a combination of a source (downdraft) and translation. In both of these cases, however, the pattern occurred on hills (wooded portion in fig. 11), leaving the possibility that it was due to the terrain.
